**Use of Microcracking to Reduce Shrinkage Cracking in Cement Treated Bases**  
**Submitted for publication and presentation to the Transportation Research Board**

**Stephen Sebesta**  
**Associate Transportation Researcher**  
**Texas Transportation Institute**  
**Texas A&M University**  
**Room 501 CE/TTI Tower**  
**College Station, TX 77843-3135**  
**Phone: (979) 458-0194**  
**Fax: (979) 845-1701**  
**s-sebesta@tamu.edu**

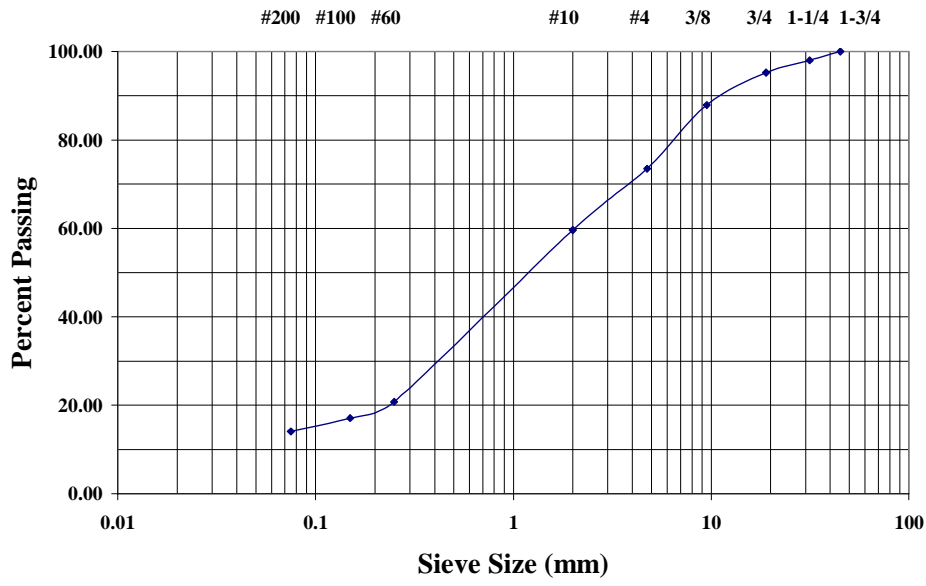
FIGURE 1 Gradation of Gravel Base used at Test Sites

The microcracking test facility was constructed at Texas A&M's Riverside Campus on September 8, 2003, and utilized a 6 inch (152.4 mm) layer of the same marginal gravel base as the residential streets described by Scullion. Figure 1 shows the gradation of the material. The maximum dry density determined by Test Method Tex-113-E is 136.5 pcf (2,186 kg/m<sup>3</sup>) at 7 percent water. A laboratory mix design based upon a 7-day strength target of 300 psi (2,068 kPa) and a final dielectric value after the Tube Suction Test of no greater than 10 determined the optimal cement content was 4 percent. The Tube Suction Test is a capillary soak test for moisture susceptibility (currently being implemented statewide by TxDOT) and is described elsewhere (14-16). Table 1 shows the results from the mixture design tests.

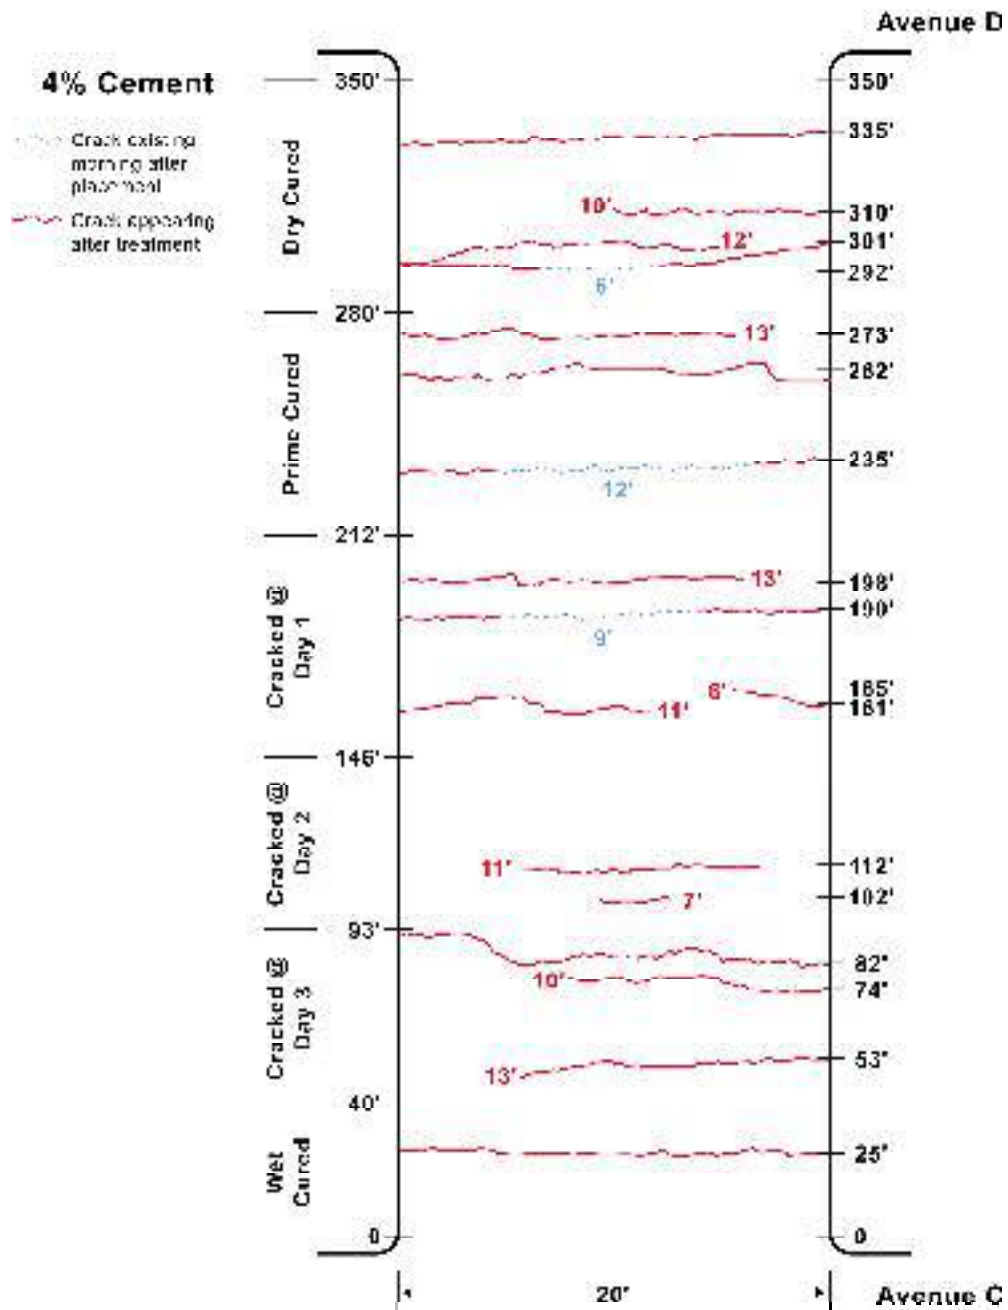
FIGURE 3 Crack Map of Site with 4 Percent Cement

Researchers conducted the first crack survey the morning after placement of the base; cracks that existed at this time would not be preventable regardless of treatment. The research team conducted the most recent survey on June 28, 2004. Figures 3 and 4 illustrate the current status of the cracking, and Table 2 summarizes the crack length statistics for the sites. Several observations are evident from the surveys:

- In general, the sites with 8 percent cement exhibited more total cracking than their counterpart treatments with 4 percent cement. The most drastic differences exist in the dry cured and prime cured sections.

- Of the sites with 4 percent cement, the site microcracked at two days cure currently has the best cracking performance.
- Of the sites with 8 percent cement, the site moist cured currently has the least amount of total cracking; however, microcracking at 3 days cure was most effective at preventing additional cracks from occurring. For example, the site cracked after 3 days already had 80 feet (24.4 m) of cracks per 100 linear feet (30.5 m) road before microcracking; after treatment the total crack length has increased by only 10 percent. In contrast, the moist cured section initially had no cracks in it but over time has progressively shown a steadily increasing amount of cracking.

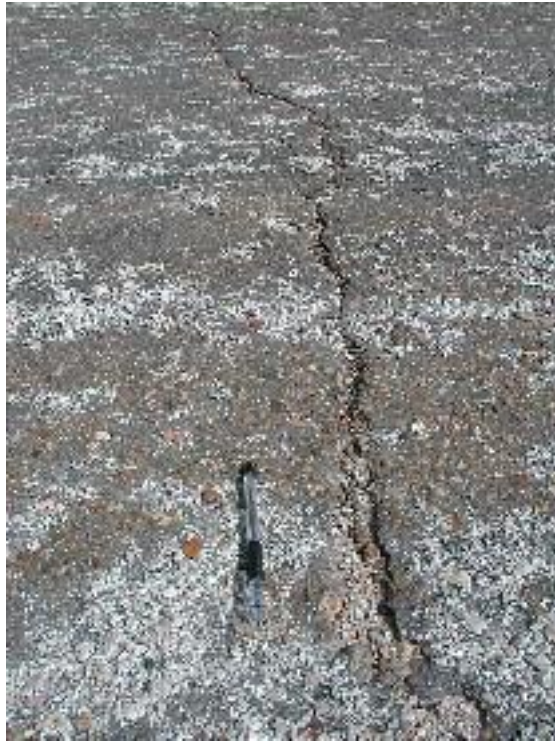
**(a) Dry Cured**

**FIGURE 5 Worst (a) and Least (b) Severe Cracks in 4 Percent Cement Test Site**

Two mechanisms exist by which microcracking can reduce shrinkage cracking problems. First, microcracking can reduce the total amount of cracking; second, microcracking can reduce the severity (width) of the cracks. Table 2 shows microcracking substantially reduced preventable crack length in the site with 8 percent cement. The only major reduction in total crack length at the site with 4 percent cement is with the section microcracked after 2 days cure. However, drastic differences in crack severity exist in the site with 4 percent cement. As noted in Table 2, the crack width in sections that were wet cured or dry cured is such that spalling is starting to occur. In contrast, the cracks in sections that were microcracked are less severe. Figure 5 contrasts the

widest to the tightest cracks in the sections with 4 percent cement. In some cases (see Figure 5b) some of the cracks are so tight they are barely visible. Differences in crack severity also exist in the site with 8 percent cement, with cracks in the microcracked sections less severe than others. In general the research team observed crack severity decreased with microcracking as compared to the dry cured, wet cured, and prime cured sections. Thus the performance of the sites indicate that in some cases, especially on bases with high cement contents, microcracking will significantly reduce the amount of cracking in the base; however, even if total crack length is not substantially reduced, crack severity is significantly reduced by microcracking, regardless of mixture design.

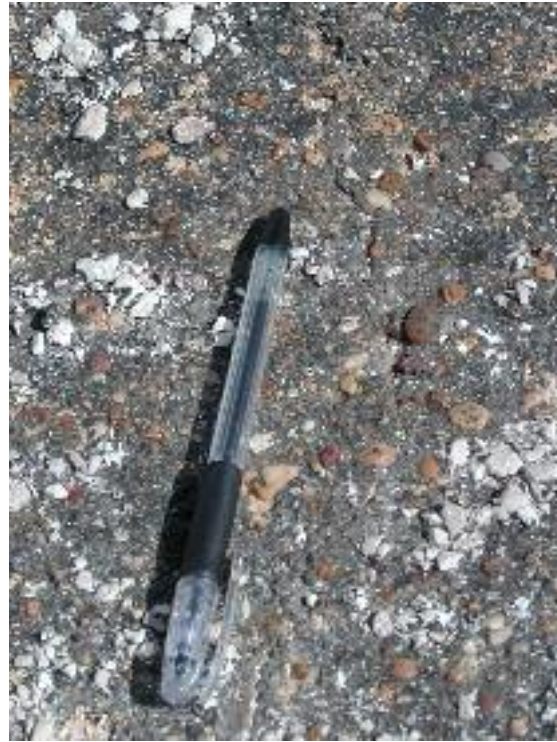
**(b) Microcracked at 3 Days Cure**

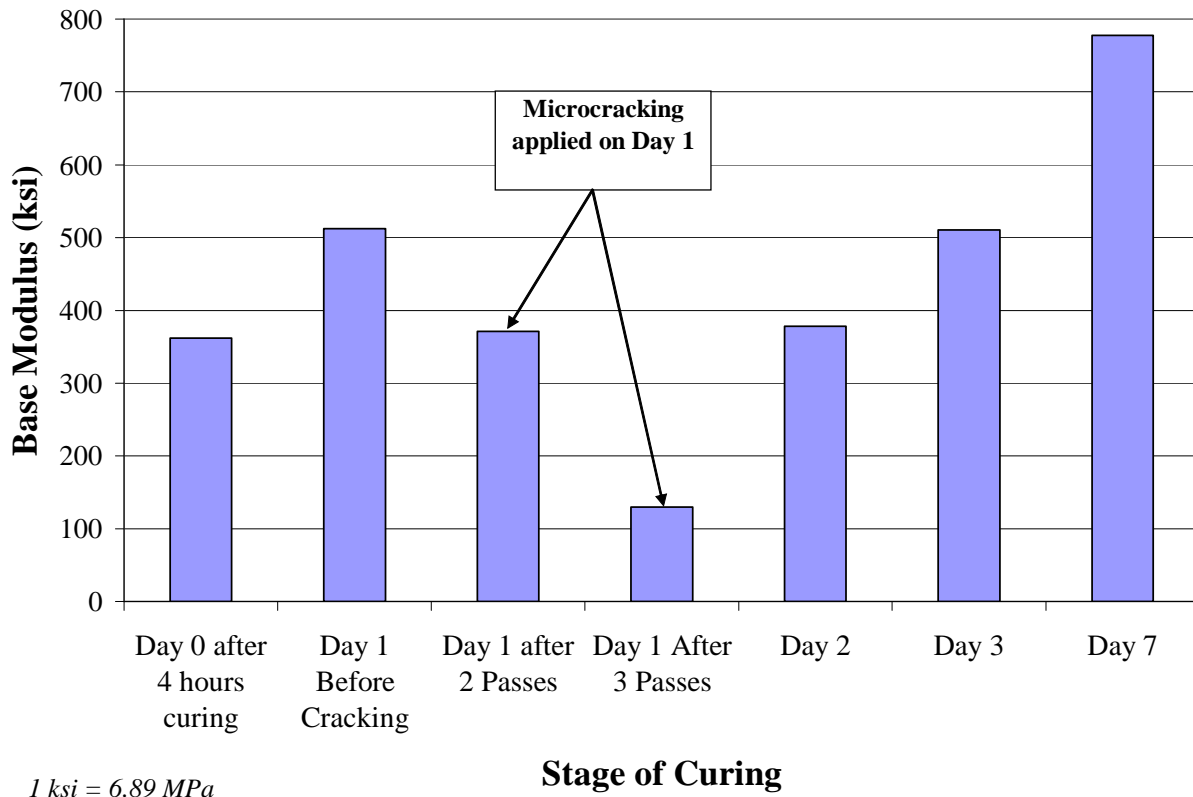
FIGURE 6 Typical Pattern of Base Modulus Changes with Microcracking

Figure 6 illustrates the typical pattern of changes in base modulus with the microcracking procedure. As curing proceeds, the base modulus increases. The change from Day 0 to Day 1 in Figure 6 shows this increase. Then, during the initial passes of microcracking (one pass is down and back), minimal change in the base modulus takes place. Figure 6 shows how after 2 passes the modulus only decreased 25 percent. Then, with one additional pass, the base modulus suddenly drops drastically. At this point the base is satisfactorily microcracked. The base modulus then recovers quickly since microcracking takes place early in the curing stage of the material.

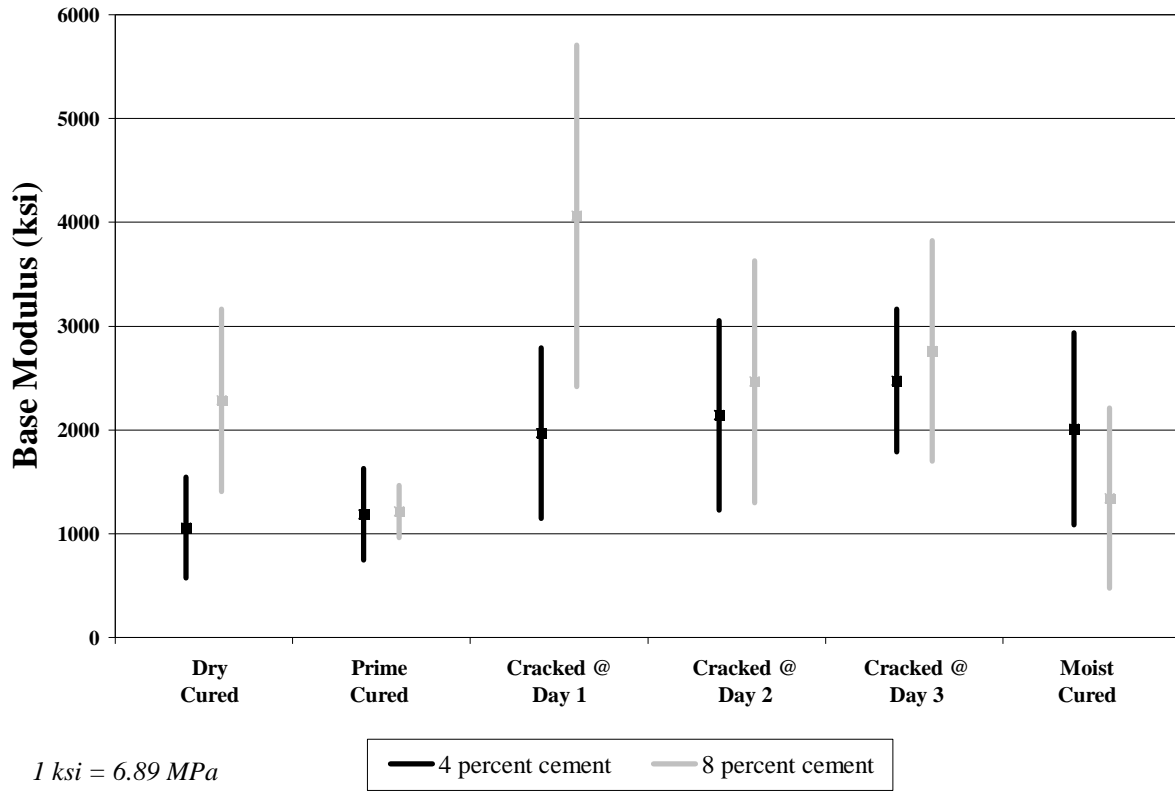
FIGURE 7 Average Base Moduli for Riverside Test Sites, June 2004

Two key questions arise regarding the modulus of the base from microcracking. First, since time and equipment limitations prevent the use of a FWD on every microcracking project, field engineers need to know how much rolling to perform. Second, the in-service modulus of the microcracked layer must be satisfactory. Regarding the amount of rolling, the contractor applied 3 passes to each of the microcracked sections with 4 percent cement and achieved an average reduction in base modulus of 60 percent, with a range of 51 to 70 percent reduction. At the site with 8 percent cement, the contractor applied 2.5 to 4 passes and achieved an average reduction in base modulus of 65 percent with a range of 58 to 69 percent reduction. Thus, field experience at these test sites indicates 3 passes of the vibratory roller should be sufficient to obtain the desired results. With respect to eventual in-service base modulus, Figure 7 shows the average base moduli of the test sites from the most recent FWD measurements (June 28, 2004). Figure 7 illustrates both the observed sample mean (the square marker) and the 95 percent confidence interval for the population mean (the vertical lines) for each section. These data show:

- Microcracking has not resulted in reduced layer moduli when compared to the control (moist cured). Statistical tests show no significant difference exists in the mean base modulus between the microcracked sections and the moist cured section at the site with 4 percent cement. At the site with 8 percent cement, the section cracked after one day, and the section cracked after 3 days, both have statistically significant greater mean moduli values than the moist cured section.
- With the exception of the dry-cured sections and the sections cracked at one day, currently no difference in mean modulus value exists between the two cement contents when constructed and cured with identical techniques. The higher cement content in general has not resulted in a significantly increased in-service modulus.

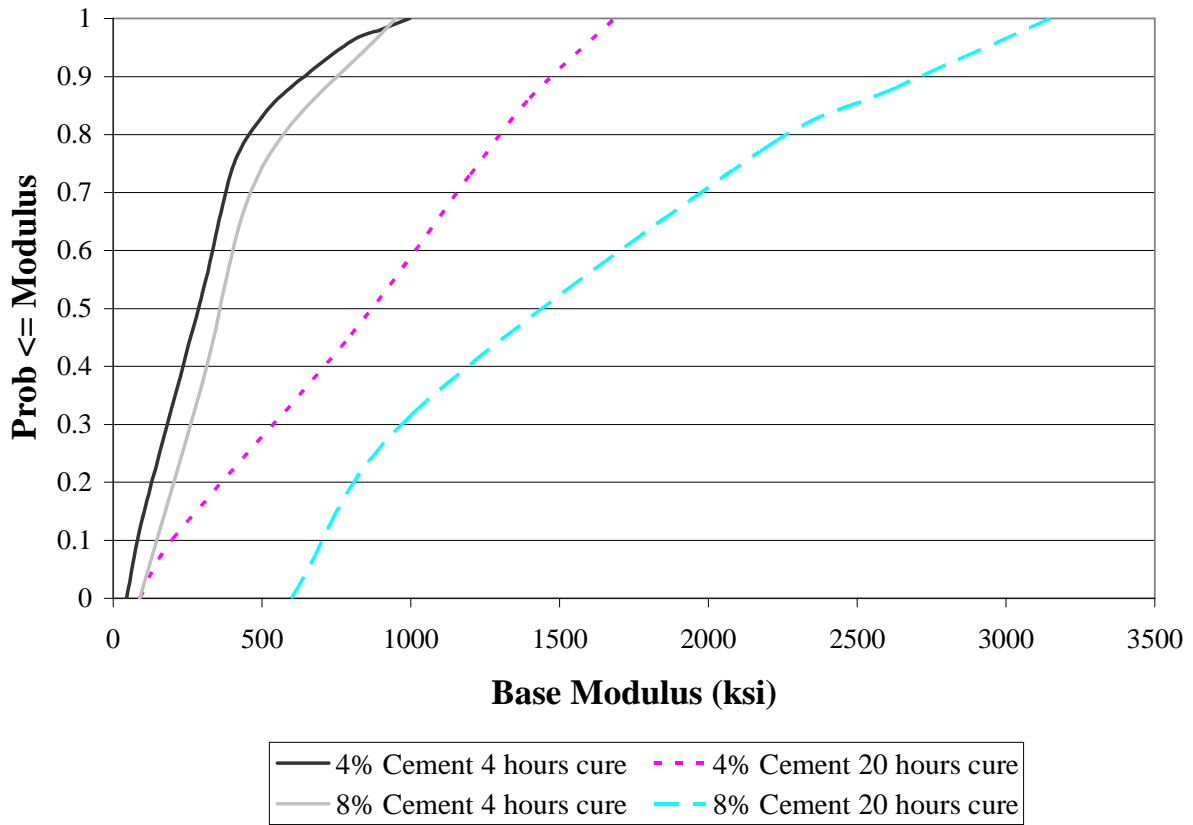
**FIGURE 8 Distributions of Base Moduli in Test Sites after 4 and 20 Hours Curing**

A secondary issue that arose from this work was questions regarding how quickly traffic can be allowed on cement-treated layers. TxDOT specifications require a 3 day moist cure; however in instances of emergency repairs TxDOT needs to open the road sooner. Figure 8 shows the distribution of observed moduli for the sites the afternoon of placement, representing a curing time of approximately 4 hours, and the morning after placement, representing approximately 20 hours curing. The site with 4 percent cement had an average base modulus on the day of placement of 362 ksi (2,496 MPa), and 90 percent of these observations were greater than 65 ksi (448 MPa). The morning after placement the average modulus at this site was 874 ksi (6,026 MPa) with 90 percent of observations greater than 200 ksi (1,379 MPa). With 8 percent cement, the average base modulus was 436 ksi (3,006 MPa) the day of placement, and 90 percent of these observations were greater than 100 ksi (689 MPa). This average modulus value increased to 1690 ksi (11,652 MPa) the morning after placement, with 90 percent of observations at least 650 ksi (4,482 MPa). For reference, a typical Texas flexible base has an in-service resilient modulus value in the range of 40-100 ksi (276-689 MPa). The data indicate earlier trafficking of this cement-treated base than what is typically allowed should not pose a problem. Similarly, work performed by Guthrie et. al. recently indicated trafficking could be permitted as early as after 8 hours curing on a section constructed with full-depth recycling and 2 percent cement (17).
