# Full-Depth Reclamation using Portland Cement: A Study of Long-Term Performance

By Imran M. Syed, Ph.D

Thomas L. Brown Associates, P.C.

**Portland Cement Association**

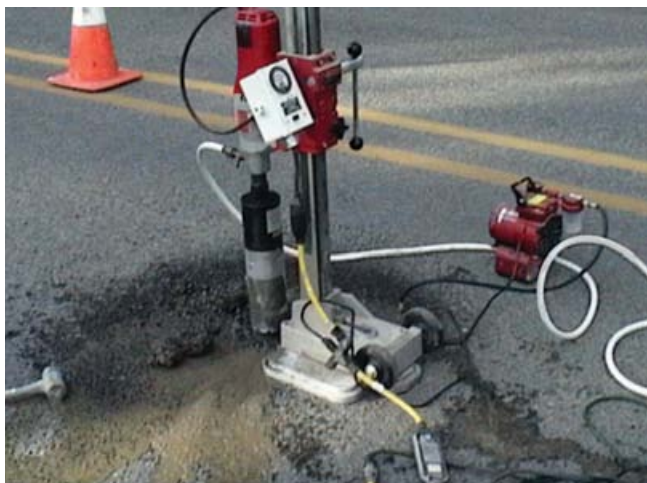
**Figure 3. Coring FDR with Cement Roadways.**

Representative core samples of the reclaimed base from some of the pavement sections were visually examined and photographed. Upon confirmation of their in-situ condition, the cores were subjected to laboratory strength measurements to determine the in-situ strength of the reclaimed base after many years of performance. Core samples were obtained from 33 locations, of which 23 were considered adequate for Unconfined Compressive Strength (UCS) measurements. The remaining samples were damaged during the coring process.

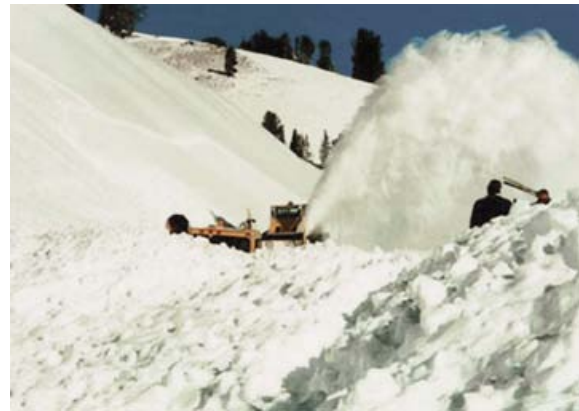
Figure 6. Example location of road in Idaho under winter conditions.

County engineers, including Jim Whitbread of Stevens County, Wash. (just south of the Canadian border) and District 6 State Engineer Tom Cole of the Idaho Transportation Department (ITD) say road heaving due to winter freeze and rutting due to spring thaw are among their biggest challenges. Mr. Whitbread reported that Stevens County roadways could heave 12 inches or more in winter. During spring thaw, the roads would become weak and

significant distress/failures would appear. Mr. Cole of ITD faced similar problems, as Idaho roads experience more than 100 inches of snowfall during most winters. The FDR with cement process has been very successful for Mr. Whitbread, Mr. Cole, and others. The heaving has been eliminated and the engineers are pleased to report that their roads are operable in cold-weather conditions.

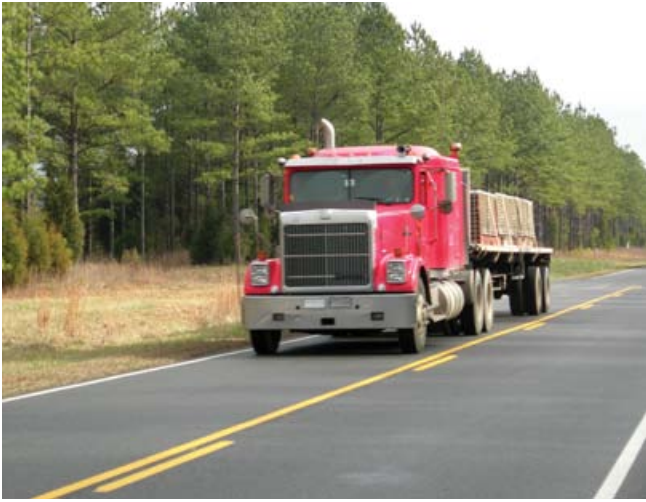
*Figure 7. FDR with Cement road in South Carolina.*

In areas with significant rainfall, durability problems due to wetting and drying are common. South Carolina Route 97 in York County had constant costly and frustrating maintenance problems, according to engineers in District 4 of the South Carolina Department of Transportation (SCDOT). Significant rainfall (48 inches per year), along with inadequate pavement structure, weak subgrades, and poor drainage, caused many problems. The road was reconstructed using the FDR with cement process in 1995.

The SCDOT District Engineer, Frank (Stan) Bland, Jr., P.E., says he is "very pleased" with the road's performance, adding that a perennial maintenance problem has stayed in good to excellent condition for more than ten years after reconstruction with the FDR with cement process.

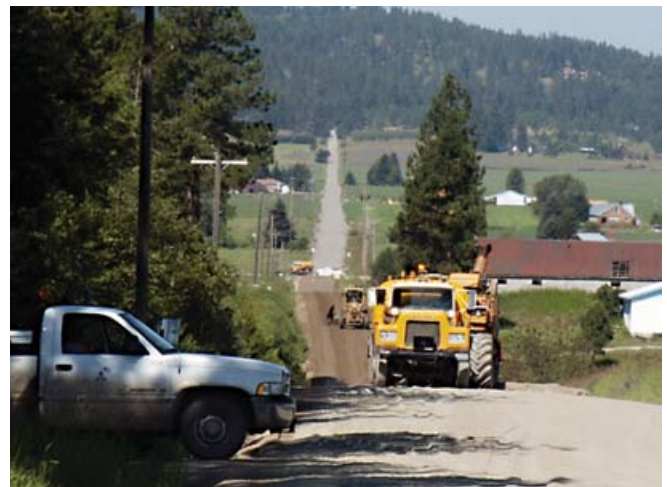
*Figure 8. FDR with cement construction, Spokane County, WA.*

The pulverization process requires that the maximum size of the crushed pavement be no more than 2.5 to 3.0 inches. Type I/II portland cement is used mostly in dry form; however, some agencies place cement in the form of a slurry. Agencies continue to search for procedures to minimize any dust that might be caused by the construction process.

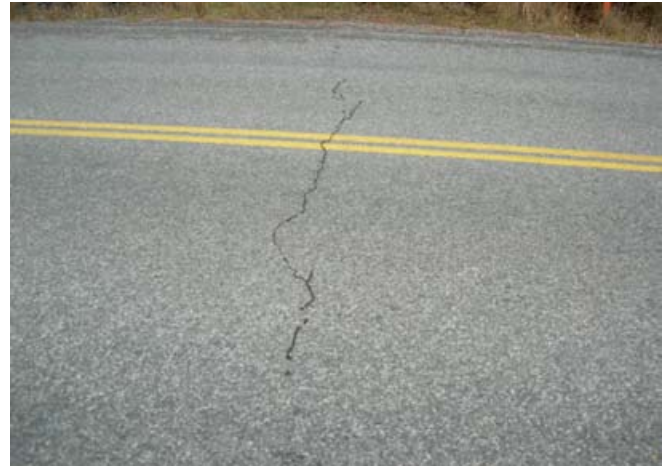
**Figure 9. Reflection cracks on FDR with cement road, Stevens County, WA.**

Some agencies, such as TxDOT, use a process called “micro-cracking” to reduce reflection cracking. This procedure uses a compaction roller on the surface of the cement-stabilized base one-to-two days after construction. The effect of the roller is to initiate hundreds of tiny micro-cracks in the base to absorb the shrinkage, rather than single shrinkage cracks that are wider. The tiny cracks are too small to reflect up through the asphalt surface.

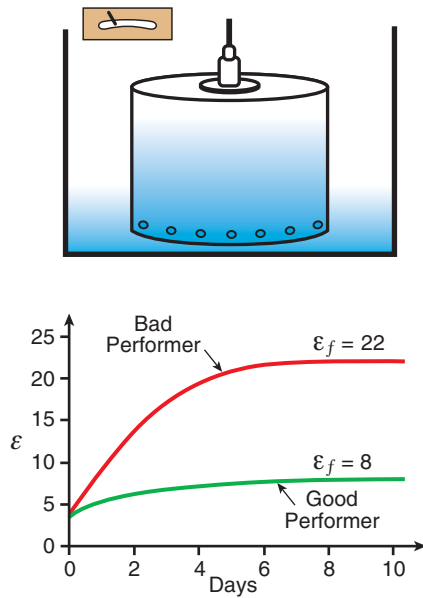
Figure 11. Depiction of Tube Suction Test set-up and results.

TxDOT addresses the moisture sensitivity issue by requiring the samples to pass the Tube Suction Test (7). Standard test specimens are placed in a ¼-inch deionized water bath whose surface is monitored for ten days by measuring the dielectric constant with a probe. Samples that do not exceed the surface dielectric constant of 10 over the ten-day period correlate with samples that are likely to pass the wet-dry (ASTM D 559) and freeze-thaw (ASTM D 560) tests.

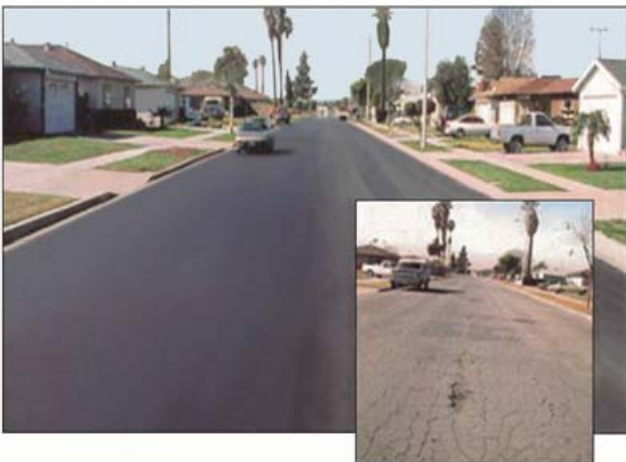
*Figure 12. Before and after photos of FDR with cement roadway in Westminster, CA.*

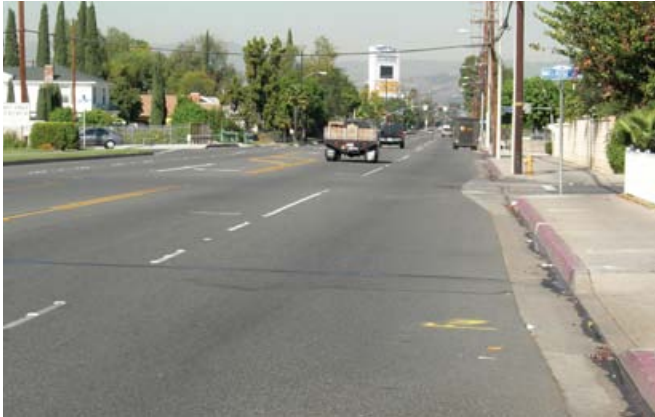
Figure 1. Western Avenue, Buena Park; Orange County, California.

<b>Owner:</b>	City of Buena Park, California
<b>Type of Use:</b>	Collector Road
<b>Year Built:</b>	1997
<b>Limits:</b>	Artesia Boulevard to Orangethorpe Avenue
<b>Thickness:</b>	9-12 inches
<b>Cement Content:</b>	6% to 10% by weight
<b>ADT:</b>	—
<b>PCI:</b>	89
<b>Annual Rainfall:</b>	15.1 inches
<b>Annual Snowfall:</b>	None
<b>Temperature:</b>	48.3°F / 84.8°F
<b>Subgrade Soils:</b>	Silty fine sand with gravel; silty clayey sand

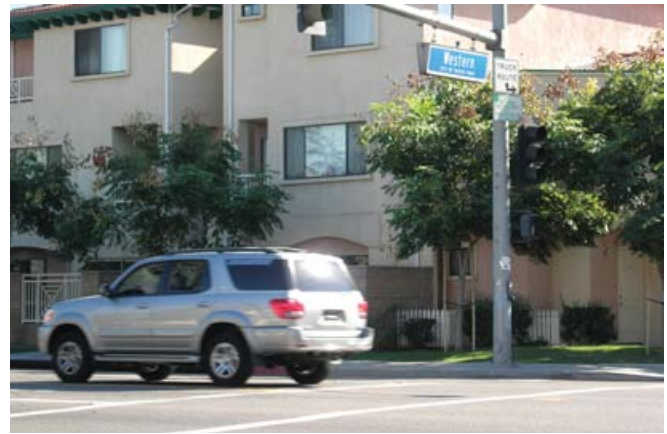
Figure 2. Truck Route, Western Avenue; Buena Park, California.

While a significant amount of truck traffic was observed on this road, the ADT or the equivalent single axle load (ESAL) information was not available. A Honda car dealership is close to the street. The street had a few utility patches, most of which had plan dimensions of 4 feet by 2 feet. One patch had plan dimensions of 25 feet by 30 feet. While some transverse cracking was apparent, there is no evidence that any of these cracks could be related to the underlying reclaimed base.

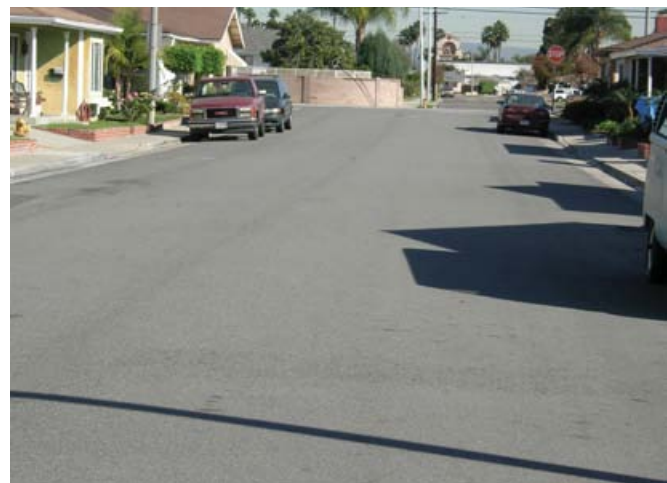
Figure 3. El Dorado Drive, Buena Park; Orange County, California.

Two other subdivision streets were also inspected. The results are summarized below:

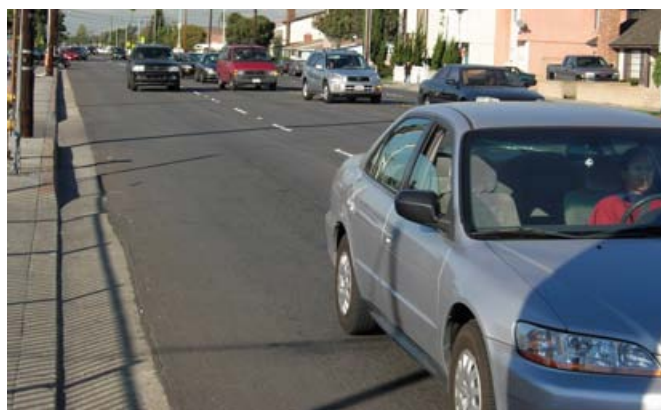
Figure 4. Edwards Street, Westminster; Orange County, California.

<b>Owner:</b>	City of Westminster, California
<b>Type of Use:</b>	Collector Road
<b>Year Built:</b>	1990
<b>Limits:</b>	Westminster Ave to Garden Grove
<b>Thickness:</b>	9-12 inches
<b>Cement Content:</b>	6% to 10% by weight
<b>ADT:</b>	—
<b>PCI:</b>	96
<b>Annual Rainfall:</b>	15.1 inches
<b>Annual Snowfall:</b>	None
<b>Temperature:</b>	48.3°F / 84.8°F
<b>Subgrade Soils:</b>	Silty fine sand with gravel; silty clayey sand

The construction process was identical to the methodology adopted by the City of Buena Park. Since the street was open to local traffic almost immediately, the flow of traffic in the vicinity of the FDR process was maintained. Of the four lanes on both sides of the street, only two were closed at any given time on either side. The Contractor performed the reclamation work with the FDR technique on the two outside lanes and then moved to the inside, allowing traffic to continually flow, which is another advantage of this process. Most road rehabilitation projects close down roads completely.

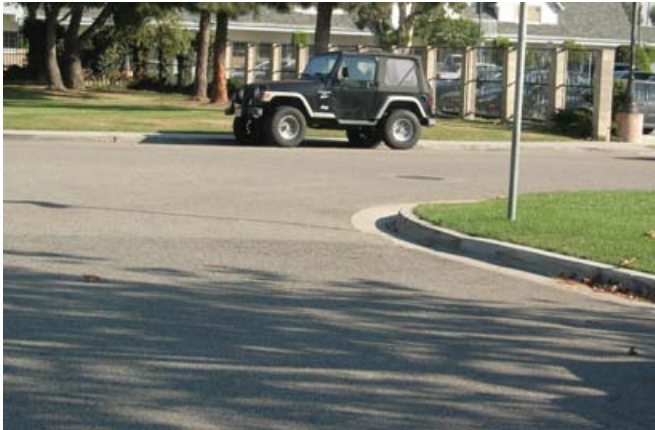
Figure 5. 18th Street, Westminster; Orange County, California.

Summary of the additional pavement inspections are as follows:

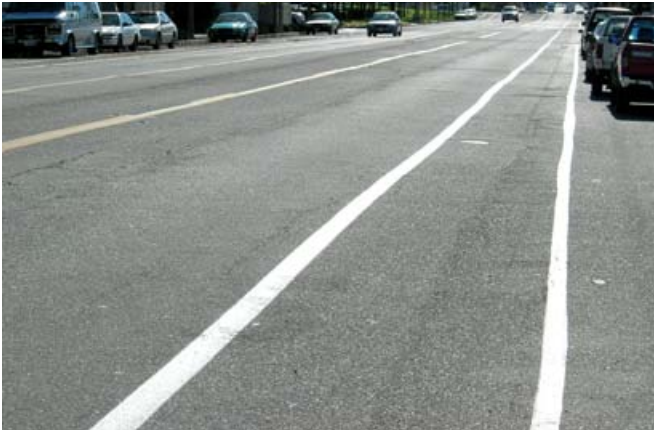
Figure 6. Acacia Avenue, Fullerton; Orange County, California.

<b>Owner:</b>	City of Fullerton, California
<b>Type of Use:</b>	Collector Road
<b>Year Built:</b>	1989
<b>Limits:</b>	Orangethorpe Avenue to Commonwealth Avenue
<b>Thickness:</b>	9-12 inches
<b>Cement Content:</b>	6% to 10% by weight
<b>ADT:</b>	—
<b>PCI:</b>	87
<b>Annual Rainfall:</b>	15.1 inches
<b>Annual Snowfall:</b>	None
<b>Temperature:</b>	48.3°F / 84.8°F
<b>Subgrade Soils:</b>	Silty fine sand with gravel; silty clayey sand.

In 1989 this street was maintained by the Orange County Engineering Department. At that time, more than half of this project called for removal and reconstruction of the roadway at a cost of \$2.15 per square yard. Instead, this road was rehabilitated with the FDR with cement process at a cost of \$1.38 per square yard, resulting in a savings of more than 35% as well as employing a more environmentally friendly process. The surface layer was 2.5 inches thick HMA. The street has been in service since 1989 and the FDR base is performing well. This street is located in an industrial area and has significant truck traffic. A visual inspection revealed some block cracking at the intersections, and some mild alligator cracking in a small section of the street.

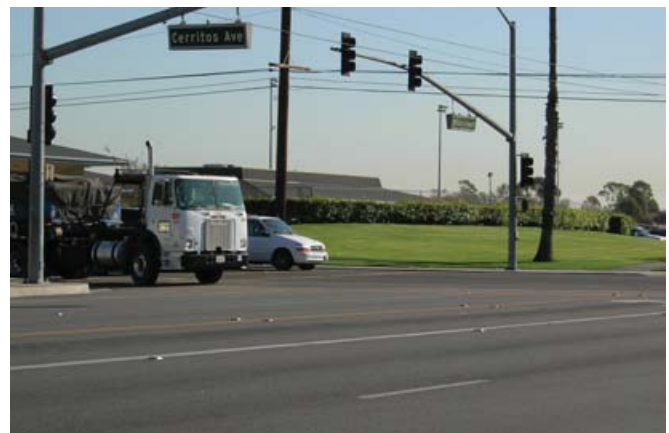
Figure 8. Bloomfield Street, Los Alamitos; Orange County, California.

<b>Owner:</b>	City of Los Alamitos, California
<b>Type of Use:</b>	Collector Road
<b>Year Built:</b>	1989
<b>Limits:</b>	Cerritos Avenue to Ball Road
<b>Thickness:</b>	9-12 inches
<b>Cement Content:</b>	6% to 10% by weight
<b>ADT:</b>	—
<b>PCI:</b>	94
<b>Annual Rainfall:</b>	15.1 inches
<b>Annual Snowfall:</b>	None
<b>Temperature:</b>	48.3°F / 84.8°F
<b>Subgrade Soils:</b>	Silty fine sand with gravel; silty clayey sand.

The removal and reconstruction of the roadway for this project section was estimated at \$1.97 per square foot in 1989. The Orange County Engineering Department decided to use the FDR with cement process, which cost \$0.99 per square foot in 1989, a savings of more than 50%. The surface layer is comprised of a 2.5-inch thick HMA overlay. Barring minor asphalt maintenance, the street has had a successful performance from the FDR base layer. The inspection revealed some minor cracking on the pavement surface. Overall, the roadway looks to be in great shape. The city has an improved base for better asphalt performance, along with reduced chances for potholes.

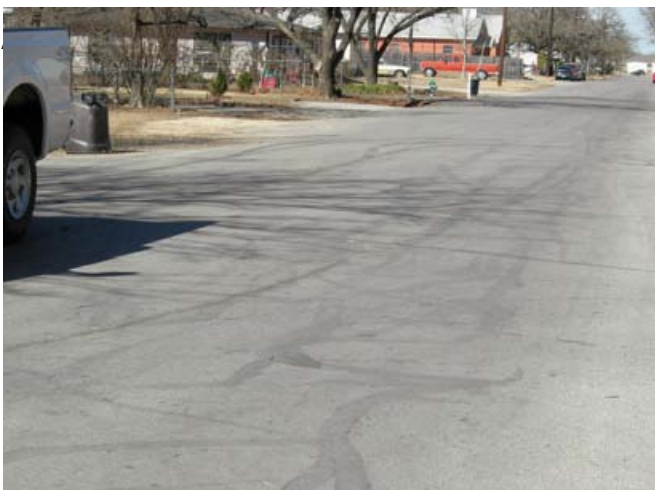
Figure 9. Belknap Street, Stephenville; Erath County, Texas.

<b>Owner:</b>	City of Stephenville, Texas
<b>Type of Use:</b>	Local Road
<b>Year Built:</b>	1993
<b>Limits:</b>	Collins Street to Frey Street
<b>Thickness:</b>	6 inches
<b>Cement Content:</b>	5% by weight
<b>ADT:</b>	—
<b>PCI:</b>	89
<b>Annual Rainfall:</b>	29.7 inches
<b>Annual Snowfall:</b>	2.1 inches
<b>Temperature:</b>	30.0°F / 93.6°F
<b>Subgrade Soils:</b>	Clay and sand

visual inspection of the street showed some minor longitudinal cracking. Overall, the pavement is in good condition and there was no evidence of problems with the reclaimed base layer. The City has been reclaiming its streets since 1992, and has had positive experiences with the FDR process. The streets have performed well and the city has been able to direct its resources toward other problems.

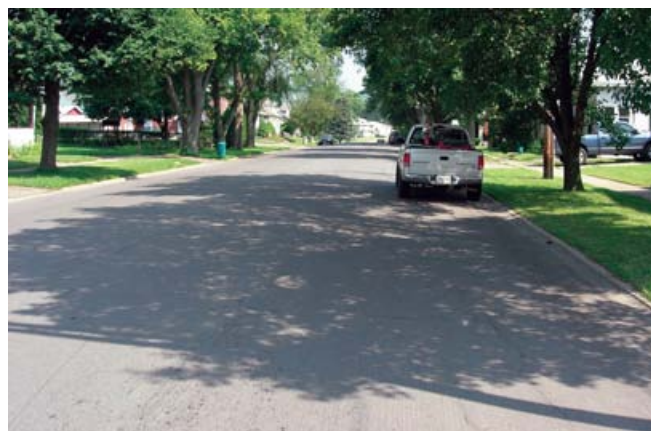
Figure 10. North McKinley Avenue, Village of Endicott, New York.

<b>Owner:</b>	Village of Endicott, New York
<b>Type of Use:</b>	Local Road
<b>Year Built:</b>	1980
<b>Limits:</b>	Jenkins Street to Pine Street
<b>Thickness:</b>	6 inches
<b>Cement Content:</b>	4% to 5% by weight
<b>ADT:</b>	Heavy, especially during peak hours
<b>PCI:</b>	73
<b>Annual Rainfall:</b>	42.3 inches
<b>Annual Snowfall:</b>	91.3 inches
<b>Temperature:</b>	11.2°F / 83.6°F
<b>Subgrade Soils:</b>	Silty clay

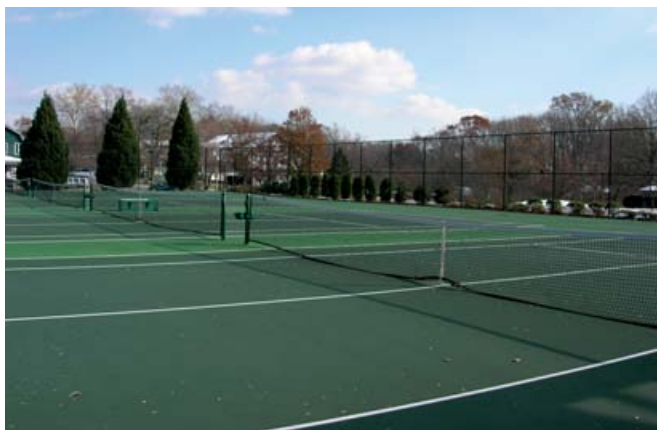
Figure 11. Sherwood Forest Tennis Courts, Crownsville, Maryland.

<b>Owner:</b>	Sherwood Forest, Crownsville, Maryland
<b>Type of Use:</b>	Tennis Courts
<b>Year Built:</b>	2002
<b>Limits:</b>	—
<b>Thickness:</b>	12 inches
<b>Cement Content:</b>	4% to 5% by weight
<b>ADT:</b>	—
<b>PCI:</b>	98
<b>Annual Rainfall:</b>	44.8 inches
<b>Annual Snowfall:</b>	4.5 inches
<b>Temperature:</b>	23.8°F / 87.7°F
<b>Subgrade Soils:</b>	Silty clay

In 2002, the tennis courts showed extensive distress. The FDR with cement process was used to reclaim the courts that were comprised of a five-inch thick asphalt layer supported on the silty clay subgrade. The asphalt layer and the underlying clay subgrade were pulverized to a depth of 12 inches. After re-shaping, 50 pounds per square yard of cement was mixed to obtain a total depth of 12 inches. The tennis courts were moist-cured for seven days, and appear in good condition with hardly any distress.

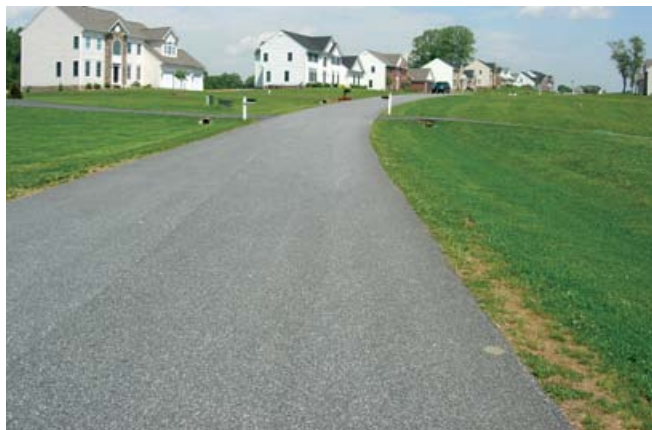
Figure 12. Water Vale Farm, Bel Air; Harford County, Maryland.

<b>Owner:</b>	Water Vale Farm; Bel Air, Maryland
<b>Type of Use:</b>	Residential Streets
<b>Year Built:</b>	2002
<b>Limits:</b>	—
<b>Thickness:</b>	12 inches
<b>Cement Content:</b>	5% to 6% by weight
<b>ADT:</b>	—
<b>PCI:</b>	98
<b>Annual Rainfall:</b>	43.8 inches
<b>Annual Snowfall:</b>	12.8 inches
<b>Temperature:</b>	23.8°F / 87.7°F
<b>Subgrade Soils:</b>	Silty sandy clay

The residential streets had perennial maintenance issues due to weak subgrade soils comprised of silty, sandy clay. The road was reclaimed by the FDR with cement process. The existing roadway, comprised of 8 inches of asphalt and base material, was pulverized and mixed with the underlying subgrade soils along with an additional 52 pounds per square yard of cement, to obtain a completed layer 12 inches deep. The reclaimed base was moist-cured for seven days. A two-inch thick HMA overlay was placed as the surface layer.

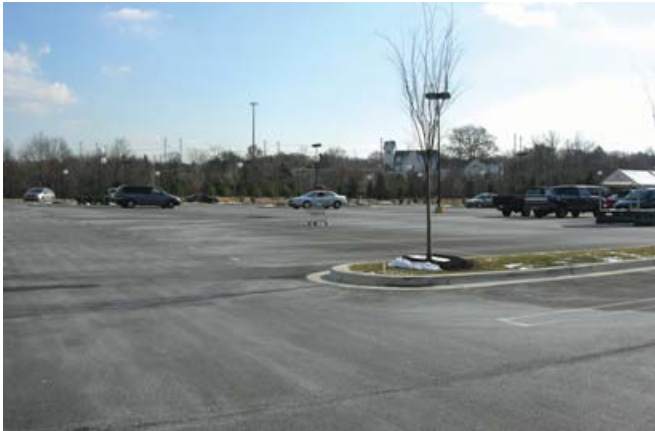
Figure 13. East Gate Shopping Center; Glendale, Maryland.

<b>Owner:</b>	East Gate Shopping Center; Glendale, Maryland
<b>Type of Use:</b>	Parking
<b>Year Built:</b>	2002
<b>Limits:</b>	—
<b>Thickness:</b>	12 inches
<b>Cement Content:</b>	7% to 8% by weight
<b>ADT:</b>	—
<b>PCI:</b>	95
<b>Annual Rainfall:</b>	43.8 inches
<b>Annual Snowfall:</b>	12.8 inches
<b>Temperature:</b>	23.5°F / 87.2°F
<b>Subgrade Soils:</b>	Silty clay

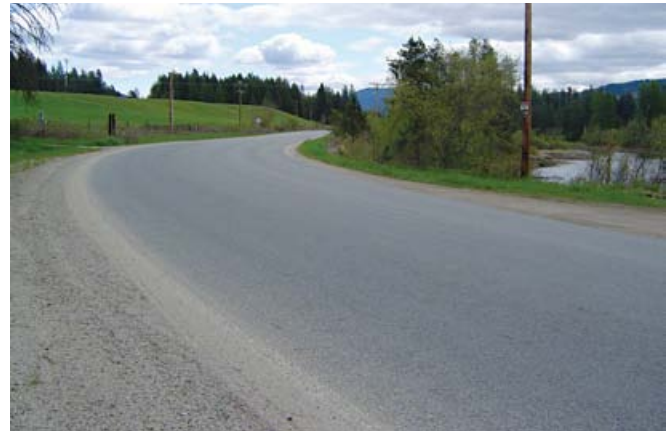
Figure 14. Dufort Road; Bonner County, Idaho.

<b>Owner:</b>	Bonner County, Idaho
<b>Type of Use:</b>	Collector Road
<b>Year Built:</b>	1997
<b>Limits:</b>	15 miles in length
<b>Thickness:</b>	10 inches
<b>Cement Content:</b>	3% to 5.5% by weight
<b>ADT:</b>	—
<b>PCI:</b>	78
<b>Annual Rainfall:</b>	33 inches
<b>Annual Snowfall:</b>	120 inches
<b>Temperature:</b>	19.0°F / 80.0°F
<b>Subgrade Soils:</b>	Varies from clays to silts to sands to gravels

Dufort Road was reconstructed with the FDR with cement process in 1997. The reclaimed base layer was 10 inches thick with 2.5 inches of HMA and chip seal. A visual inspection revealed some minor block cracking of low severity, as well as good, positive drainage in the roadway section. Geotextile fabric was not used in this pavement section. The roadway gets heavy truck traffic from a sawmill located at one end. The overall pavement condition was good. In addition to Dufort Road, some other pavement sections were also inspected. The results are summarized in the adjacent column:

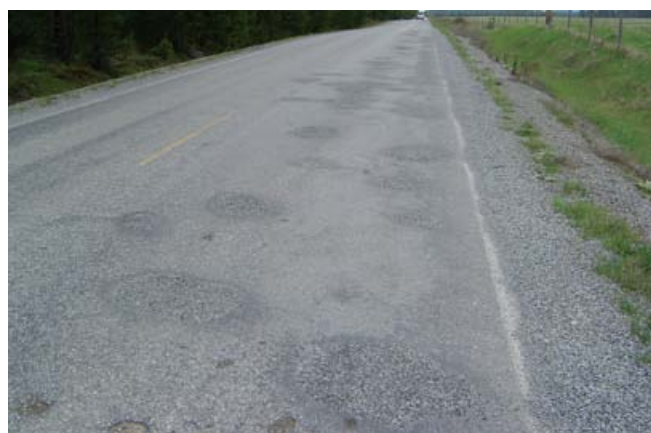
**Figure 15. Spirit Lake Cut Off; Bonner County, ID.**

The Spirit Lake Cut Off road section is about 12 miles long and was constructed with the FDR with cement process in 1998. This roadway section is comprised of 10 inches of reclaimed base, a geotextile fabric, and 2.5 inches of HMA and chip seal. The pavement evaluation revealed significant potholes up to three inches deep across the roadway, as well as substantial rutting and minor settling in some areas. Since the PCI is based on functional features, the PCI for this roadway dropped to 43. This issue needs to be investigated further, but a close visual examination indicates that the pavement distresses appear to be within the asphalt layer.

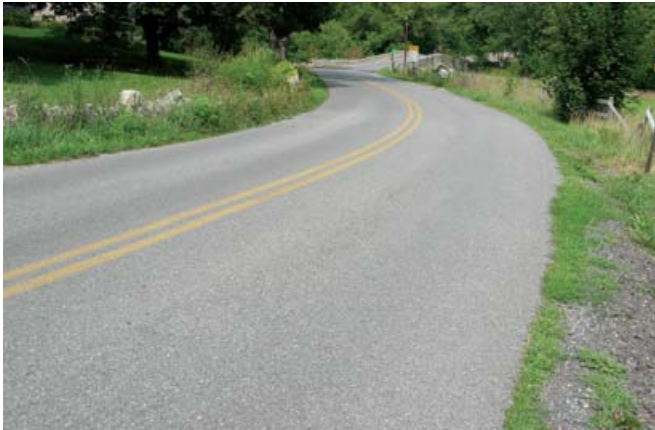
Figure 16. Poffenburger Road; Washington County, Maryland.

<b>Owner:</b>	Washington County, Maryland
<b>Type of Use:</b>	Local Road
<b>Year Built:</b>	2001
<b>Limits:</b>	Railroad crossing east of MD 65 to the bridge over Antietam Creek
<b>Thickness:</b>	9.5 inches
<b>Cement Content:</b>	3% by weight
<b>ADT:</b>	1,390
<b>PCI:</b>	96
<b>Annual Rainfall:</b>	39.5 inches
<b>Annual Snowfall:</b>	27 inches
<b>Temperature:</b>	20.8°F / 86.1°F
<b>Subgrade Soils:</b>	Silty clays and sands

Almost all the roads inspected were local roads, located mostly in areas with agricultural and industrial traffic. Observers noted some longitudinal cracking in the median of the roads as a primary distress, along with minor edge cracking. Overall, the roads appear to be in very good shape.

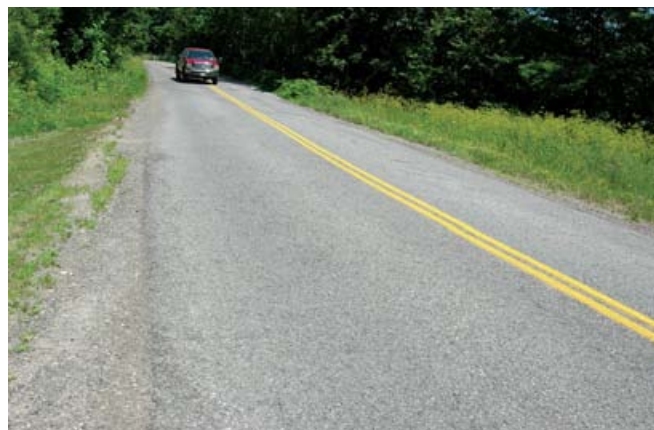
Figure 17. Polin Road, Montgomery County, New York.

<b>Owner:</b>	Montgomery County, New York
<b>Type of Use:</b>	Local Road
<b>Year Built:</b>	2000
<b>Limits:</b>	State Route 30A to Reed Hill Road
<b>Thickness:</b>	8.0 inches
<b>Cement Content:</b>	3% to 5% by weight
<b>ADT:</b>	150
<b>PCI:</b>	89
<b>Annual Rainfall:</b>	36.2 inches
<b>Annual Snowfall:</b>	52.9 inches
<b>Temperature:</b>	11.0°F / 84.0°F
<b>Subgrade Soils:</b>	Sandy clays and silts

In addition, an inspection of the following roads revealed longitudinal cracking of low to medium severity along the road medians. Some locations also displayed corrugations and rutting of low to medium severity. The pavement distresses were observed in the asphalt layer, while the reclaimed layer seemed to be in good condition. The individual PCIs are summarized below.

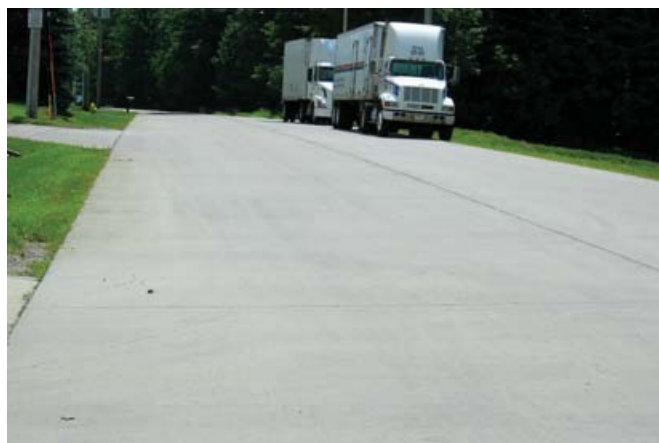
Figure 18. West Park Circle Drive, Geauga County, Ohio.

<b>Owner:</b>	Geauga County, Ohio
<b>Type of Use:</b>	Local Road
<b>Year Built:</b>	1996
<b>Limits:</b>	Washington Street (SR 606) to Park Circle Drive
<b>Thickness:</b>	12 inches
<b>Cement Content:</b>	12% by weight
<b>ADT:</b>	—
<b>PCI:</b>	82
<b>Annual Rainfall:</b>	37.3 inches
<b>Annual Snowfall:</b>	49.5 inches
<b>Temperature:</b>	16.0°F / 81.0°F
<b>Subgrade Soils:</b>	Silts and clays

and blended with 12% portland cement by dry weight of roadway material to produce a compacted reclaimed base layer of 12 inches thick. A 9-inch thick portland cement concrete pavement was placed over the reclaimed base. The visual inspection indicated blow-outs of medium severity at expansion joints, and patches at some joint locations on the concrete pavement surface. Overall the pavement is in good condition.

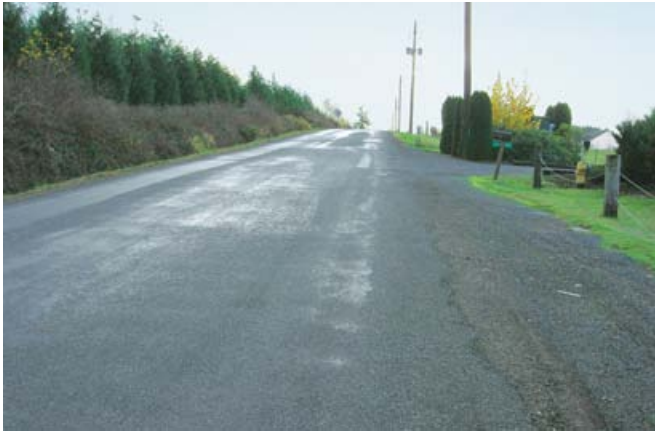
Figure 19. NE 314th Street, Clark County, Washington.

<b>Owner:</b>	Clark County, Washington
<b>Type of Use:</b>	Local Road
<b>Year Built:</b>	1999
<b>Limits:</b>	NE 102nd Avenue to NE 122nd Avenue
<b>Thickness:</b>	6 inches
<b>Cement Content:</b>	6% to 8% by weight
<b>ADT:</b>	—
<b>PCI:</b>	91
<b>Annual Rainfall:</b>	53.4 inches
<b>Annual Snowfall:</b>	4.5 inches
<b>Temperature:</b>	31.8°F / 79.1°F
<b>Subgrade Soils:</b>	Sandy silt, silty clay

NE 314th Street was one of the initial roads that was constructed with the FDR with cement process. Flushing of the asphalt emulsion was observed in some locations, along with some edge cracking due to an inadequate base layer beneath the pavement surface. In addition to NE 314th Street, the following roadways were also evaluated. All the roads receive significant truck traffic from the proximity of quarries, logging industry, agriculture and housing construction work in the area. Overall, the roads are in good condition.

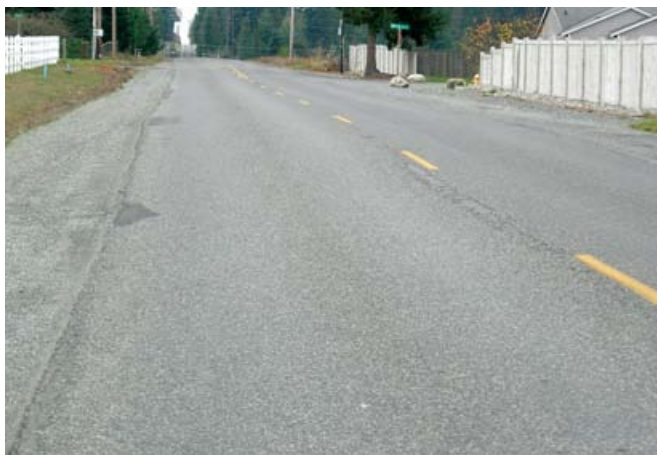
Figure 20. 224th Street East, Pierce County, Washington.

<b>Owner:</b>	Pierce County, Washington
<b>Type of Use:</b>	Local, Collector and Arterial Roads
<b>Year Built:</b>	1992
<b>Limits:</b>	Orting-Kapowsin Highway East to 146 Avenue East
<b>Thickness:</b>	6 to 8 inches
<b>Cement Content:</b>	5% to 7% by weight
<b>ADT:</b>	2,375
<b>PCI:</b>	93
<b>Annual Rainfall:</b>	48.7 inches
<b>Annual Snowfall:</b>	9.8 inches
<b>Temperature:</b>	31.7°F / 77.0°F
<b>Subgrade Soils:</b>	Silty gravel and silty sand

The segment of 224th Street East between Orting-Kapowsin Highway East to 146th Avenue East was reconstructed with the FDR with cement process in 1992. A new asphalt surface was placed in 1998. Some longitudinal and transverse cracking was observed in this project section, along with

occasional edge cracking in some areas. Other project sections that were inspected are summarized below.

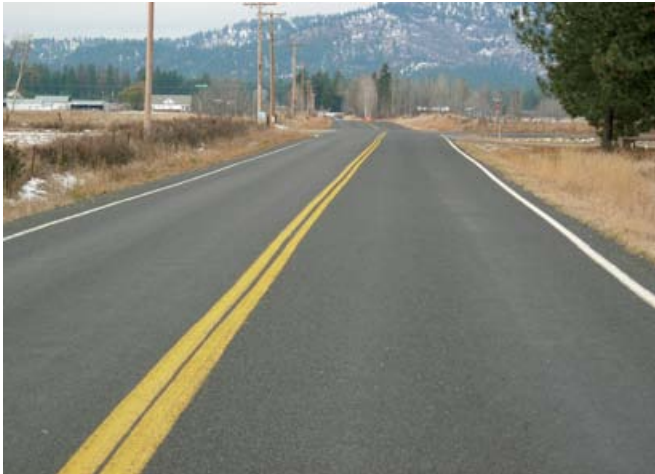
Figure 21. Charles Road, Spokane County, Washington.

<b>Owner:</b>	Spokane County, Washington.
<b>Type of Use:</b>	Local and Collector Roads
<b>Year Built:</b>	1999
<b>Limits:</b>	Long Lake Road to Dover Road
<b>Thickness:</b>	8 inches
<b>Cement Content:</b>	3% to 5% by weight
<b>ADT:</b>	617
<b>PCI:</b>	100
<b>Annual Rainfall:</b>	16.7 inches
<b>Annual Snowfall:</b>	44.5 inches
<b>Temperature:</b>	21.6°F / 82.6°F
<b>Subgrade Soils:</b>	Sandy silt and clayey sand

Charles Road was reconstructed with the FDR with cement process in 2000. A visual inspection of the roadway indicated that the pavement surface is in excellent condition without any visible distress. The following roads also underwent visual inspection. As indicated by the PCI, all the roads are in excellent condition.

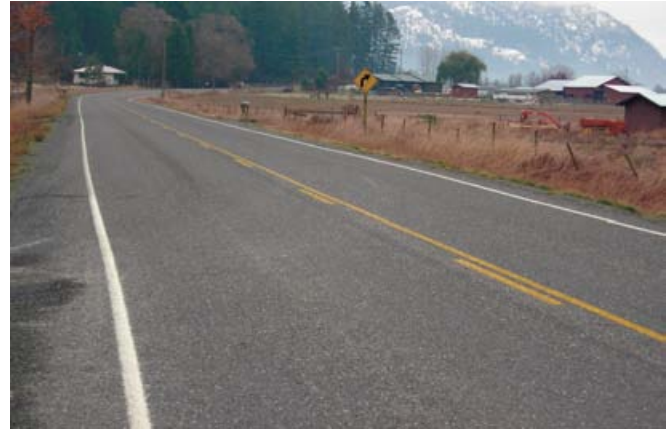
Figure 23. Williams Lake Road, Stevens County, Washington.

<b>Owner:</b>	Stevens County, Wash.
<b>Type of Use:</b>	Local and Collector Roads
<b>Year Built:</b>	1998
<b>Limits:</b>	State Highway 20 to State Highway 25
<b>Thickness:</b>	8.5 inches
<b>Cement Content:</b>	5% to 7% by weight
<b>ADT:</b>	2,350
<b>PCI:</b>	95
<b>Annual Rainfall:</b>	21.9 inches
<b>Annual Snowfall:</b>	33.9 inches
<b>Temperature:</b>	18.6°F / 86.3°F
<b>Subgrade Soils:</b>	Sandy / clayey silt and clayey sand

The pavement evaluation of Williams Lake Road, in the northwest portion of Stevens County in Echo Valley, concluded that the road is in excellent condition. Although minor longitudinal cracks in the median were noticed, there was no evidence of potential problems with the pavement surface layer or the underlying reclaimed cement-stabilized base layer.

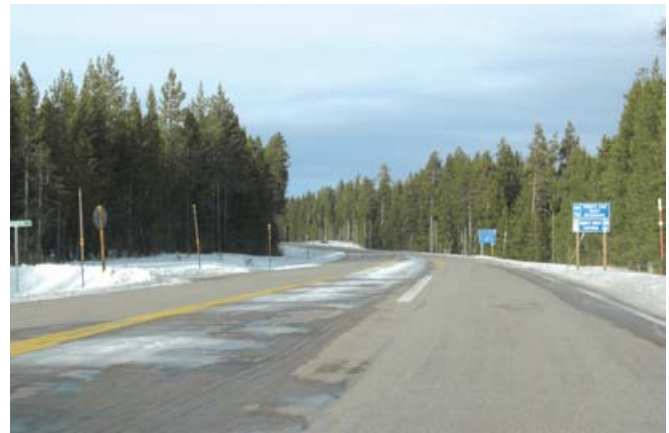
Figure 24. US-20; Ashton, Idaho.

<b>Owner:</b>	District 6, ITD
<b>Type of Use:</b>	Freeway
<b>Year Built:</b>	1993
<b>Limits:</b>	South Ashton to Dumpground Road
<b>Thickness:</b>	6.5 inches
<b>Cement Content:</b>	2% by weight
<b>ADT:</b>	5,000
<b>PCI:</b>	87
<b>Annual Rainfall:</b>	20.1 inches
<b>Annual Snowfall:</b>	100.3 inches
<b>Temperature:</b>	4.5°F / 86.6°F
<b>Subgrade Soils:</b>	Clay and sand

US-20 is a major route that runs through District 6. The section of US-20 between South Ashton and Green Canyon Road was reconstructed in 1993 with the FDR with cement process. The reclaimed layer is 6.5 inches thick with a 3.7-inch thick HMA layer. While a visual inspection revealed some low-severity longitudinal cracking, the road is in very good condition. The back calculation of FWD data with the MODULUS 5.0 program indicated that the average resilient modulus of the reclaimed base after 13 years in extreme weather conditions was 55,515 psi.

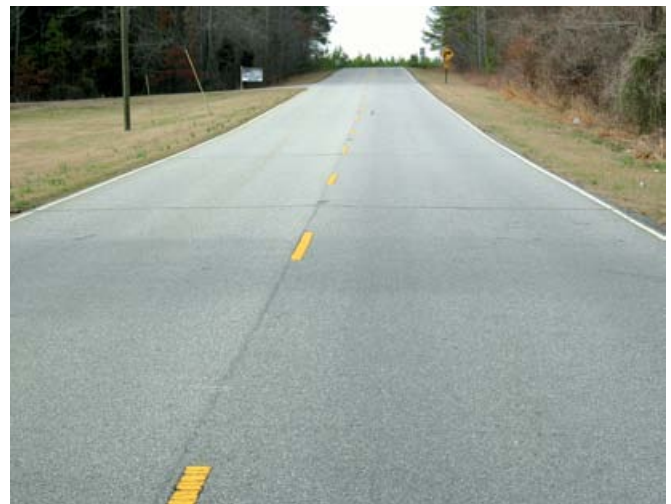
**Figure 27. SC-97; York County, South Carolina.**

**Owner:** District 4, SC DOT  
**Type of Use:** Freeway  
**Year Built:** 1995  
**Limits:** Chester County Line to Hickory Grove  
**Thickness:** 9–12 inches  
**Cement Content:** 6% by weight  
**ADT:** 375  
**PCI:** 82  
**Annual Rainfall:** 47.9 inches  
**Annual Snowfall:** 3.4 inches  
**Temperature:** 29.3°F / 90.1°F  
**Subgrade Soils:** Clay and sand

The visual inspection of the road found some low severity longitudinal and transverse cracks, which have been sealed. The overall pavement condition was good. The SCDOT engineers were pleased that the road that was formerly a perennial maintenance problem has stayed in good to excellent condition for more than ten years.

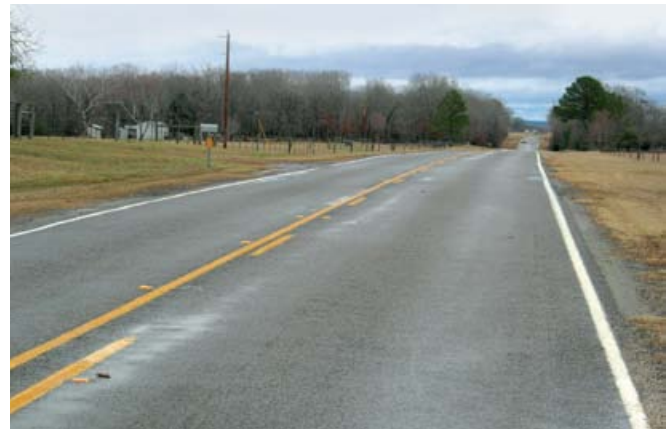
Figure 28. FM 3178; Leon County, Texas.

<b>Owner:</b>	Bryan District, Texas Department of Transportation
<b>Type of Use:</b>	Farm-to-Market Road
<b>Year Built:</b>	1996
<b>Limits:</b>	FM 1511 to FM 542
<b>Thickness:</b>	10.0 inches
<b>Cement Content:</b>	4% by weight
<b>ADT:</b>	—
<b>PCI:</b>	85
<b>Annual Rainfall:</b>	43.1 inches
<b>Annual Snowfall:</b>	0.9 inches
<b>Temperature:</b>	34.3°F / 95.0°F
<b>Subgrade Soils:</b>	Silty sandy clay

The visual inspection of FM 3178 indicated some low severity longitudinal and transverse cracks on the pavement surface which had been sealed, as well as low to medium severity edge cracking and corrugations at some locations. Some of the edge cracking could be due to heavy vehicles pulling off the road and cracking the pavement edge because of lack of

support underneath the two-course surface treatment. Overall, the pavement is in good condition as indicated by an average PCI of 85.

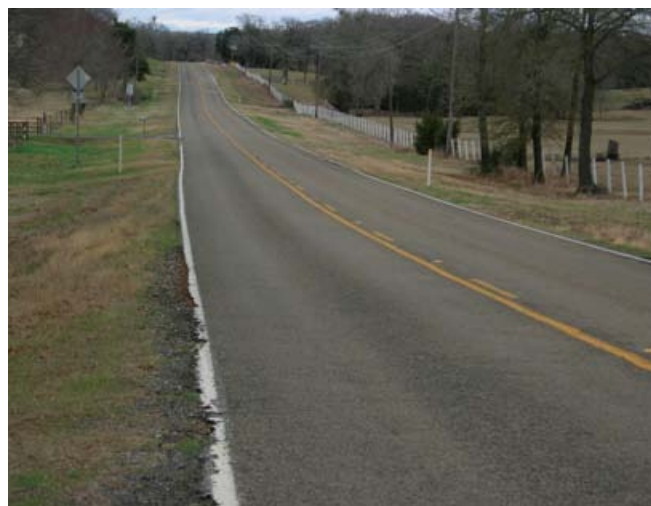
Figure 29. FM 977; Leon County, Texas.

The section of FM 977 was two miles long between FM 3 and two miles east of the intersection of FM 977 and FM 3. This section was reconstructed in 1996 with 4% portland cement by dry weight of roadway material as the stabilizer. The reclaimed layer was 10 inches thick with a two-course bituminous surface treatment. The visual inspection indicated longitudinal and transverse cracking of low to medium severity. The cracks were sealed and the seal stayed in place without any further deterioration.

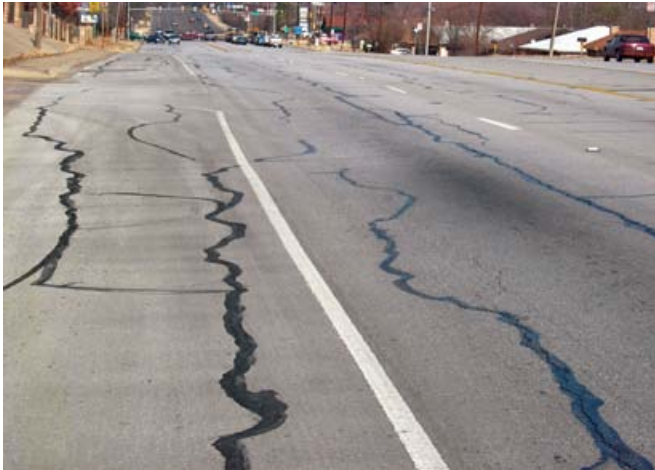
Figure 30. FM 51; Parker County, Texas.

<b>Owner:</b>	Fort Worth District, Texas Department of Transportation
<b>Type of Use:</b>	Farm-to-Market Road
<b>Year Built:</b>	1997
<b>Limits:</b>	FM 920 to Trinity River Bridge
<b>Thickness:</b>	9.0 inches
<b>Cement Content:</b>	3% by weight
<b>ADT:</b>	1,914,000 ESAL
<b>PCI:</b>	83
<b>Annual Rainfall:</b>	34.7 inches
<b>Annual Snowfall:</b>	2.0 inches
<b>Temperature:</b>	29.0°F / 95.2°F
<b>Subgrade Soils:</b>	Clayey and silty sand
